## BELZONA REBUILDS CONDUIT GAP

Battery Manufacturing Plant, NC, USA

Conduit Gap

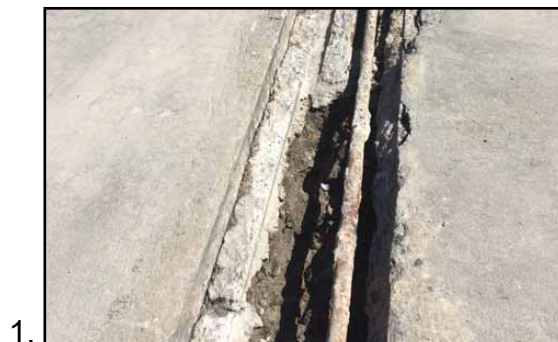
Conduit was buried in concrete. The concrete started failing.

1. Empty conduit gap.
2. Taking up volume with Belzona 4154 with river rock followed by Belzona 4154 with sand on top.
3. After spreading the Belzona 4154 with sand.
4. Top coated with Belzona 4111.

All the concrete was cleaned out and where it was not already rough, grinders were used to roughen the substrate. Belzona 4154 was mixed with clean river rock to bulkfill the conduit gap. Once the conduit gap was filled up, Belzona 4154 was mixed with sand and spread out. The bulkfill was top coated with Belzona 4111 for added strength and blend. The application was carried out in accordance with Belzona Know-How System Leaflet FPA-12.
