BELZONA REPAIRS FATTY ACIDS CONTAINMENT AREA

Specialty Chemicals Manufacturer, NC, USA

April 2015

Secondary containment area where fatty acids were stored.

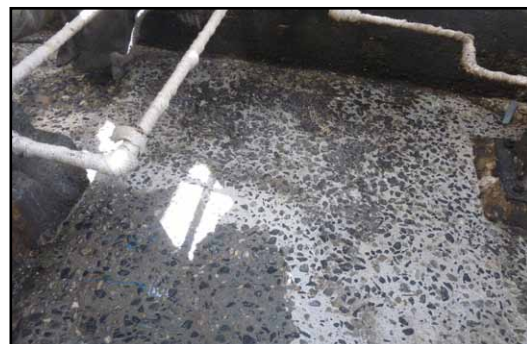
Concrete surfaces were severely corroded and eroded from leaking equipment.

1. Severely corroded and eroded concrete resulting from leaking equipment.
2. First part of the repair in contrast to the original condition. Belzona 4154 mixed with sand plus 2 coats of Belzona 5811. Draining rebuilt to eliminate ponding.
3. Closer look at the repair.
