BELZONA REPAIRS HOLES WITH BULKFILL AND MAGMA QUARTZ

Truck Part Manufacturer, NC, USA

June 2016

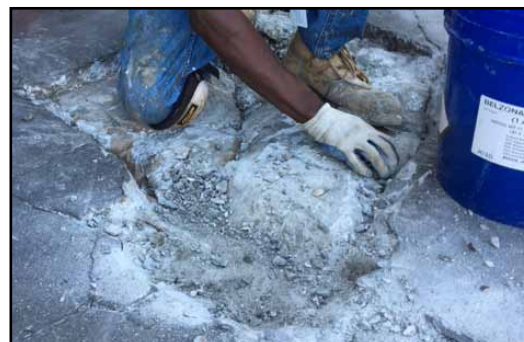
Due to continuous forklift traffic, holes had formed causing an issue in operations.

1. Preparing hole by removing loose material
2. After preparation
3. Bulkfilling with Belzona 4124
4. Top coated with Belzona 4111

The holes were cleaned out and filled with Belzona 4124. Once the holes were filled, it was top coated with Belzona 4111. FPA-1 System Leaflet was followed.
