BELZONA 7111 ALIGNS NEW INDUSTRIAL EQUIPMENT

Manufacturing Plant, FL, USA

August 2016

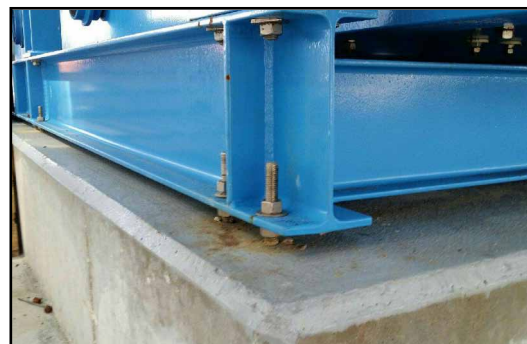
1. View of the gap needed to be filled.
2. Temporary wood dam and expansion joint.
3. Pouring of first layer.
4. After dam removal.
