LEAKING FLANGE COUPLINGS SEALED WITH BELZONA

Flange couplings at a paper press machine

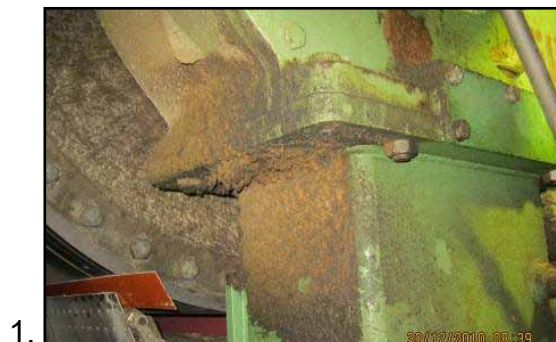
After several years in operation and due to vibration, oil started to leak from some couplings leading to pollution and loss of efficiency.

1. Leaking flange coupling
2. Surface preparation
3. Belzona repair
4. Belzona repair
