BELZONA PIPE REPAIR KEEPS COOLING TOWER IN SERVICE

Fractured pipe spraying water on a cooling tower.

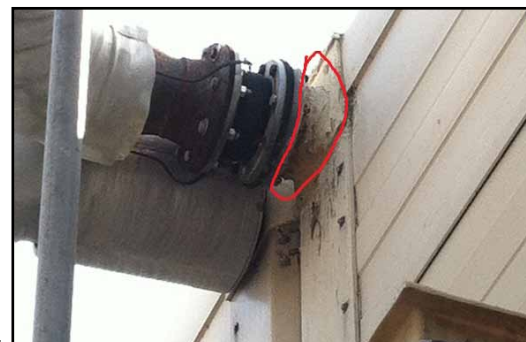
The water inlet on a cooling tower had developed a spiral crack due to the inflexible nature of the pipe and the movement of the cooling tower. It was leaking so badly that while the pumps were running, it would spray a stream of water over the side of the building onto walkways below.

1. Remnants of previous attempts to repair the pipe externally
2. Remnants of previous repair attempts inside the pipe
3. Pipe and crack cleaned, roughened and ready for the Belzona application
4. Repair completed, crack sealed with Belzona 1161 and an additional two coats of Belzona 1321
