## BELZONA REPAIRS MORE THAN 300 SPALLED CONCRETE LOCATIONS

Office building, Manchester, UK

August 2015

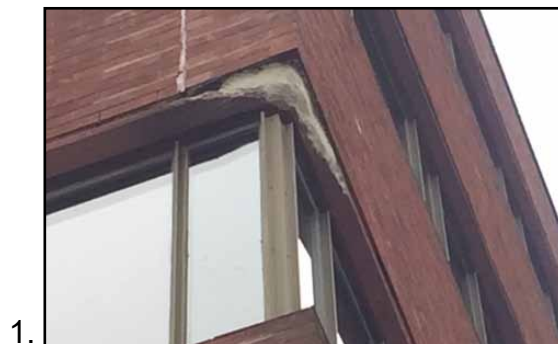
1. Deteriorated overhead lintle
2. Lintle rebuilt with colour matched Belzona 4141
3. Spalled overhead concrete
4. Overhead concrete repairs in progress

The application was undertaken in accordance with Belzona System Leaflet WPA-4. In order to access exterior areas high up on the building, a Spider MEWP (Mobile Elevating Work Platform) was used. As the building's façade is made of red brick, a powder tint was added to the Belzona 4141, ensuring the system blended in with the surrounding substrate and provided an aesthetic finish. Temporary formers were used to support the Belzona material during application and to assist in reforming edge details.
