80 TONNE BULLDOZER TRACKS-NO PROBLEM FOR BELZONA

Workshop floor where large, 80 Tonne bulldozers and excavators are maintained.

The workshop floor had been damaged by the caterpillar tracks making 180 degree turns tearing up the concrete.

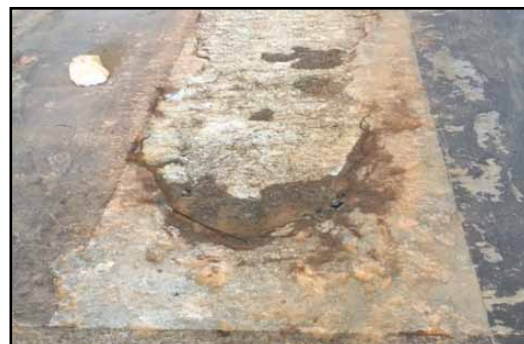
1. The damaged concrete floor
2. Another area of damage
3. Close up of the repaired area
4. View of the workshop showing repairs

Application was carried out in accordance with Belzona System Leaflet FPA-1. The floor area was badly damaged and had to be dug out to provide a suitable surface for rebuilding. Once done the area was re-built to the original level using the Belzona 4111 system.
