## BELZONA STOPS TANK LEAK AT NUCLEAR POWER PLANT

Pinhole Leaks and Thin Sidewall.

Pinholes developed in the tank that is used for emergency backup water for refueling. After testing it was discovered that a large area of the 3/16" steel sidewall was only .050 thick.

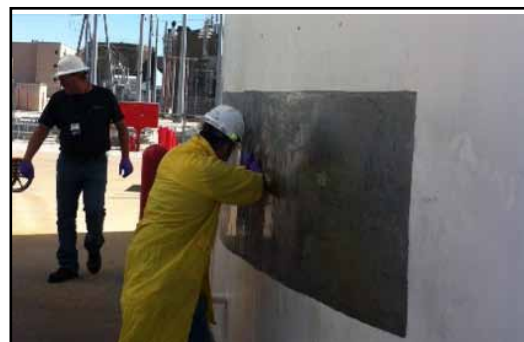
1. Plugging active leak
2. Patching over Belzona 1291
3. Applying Belzona 1111 with Belzona 9431
4. Completed application

The paint was removed and the surface was steel grit blasted to a 3 mil profile. Two of the pinholes were 1/2" in diameter and bolts with flat washers were coated with Belzona 1291 and placed into the holes. The third hole was 1/8" diameter and a sheet metal screw with a flat washer was coated with Belzona 1291 and placed into the hole. The first layer of Belzona 1111 was applied about 1/8" thick. Then Belzona 9431 was applied with the second coat of Belzona 1111.
