BELZONA RESOLVES THE RUSTY FLANGE FACE

Flange face on a pump mounted on a firetruck.

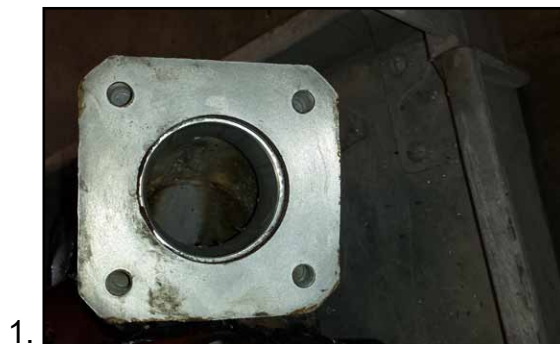
The firetruck pump sits for periods of time without being used. During this time, water sits against the flange face resulting in rust and a poor surface for the o-ring seal to sit against. This results in a lot of leaking water when the pump gets used.

1. Machined flange face
2. Opposing flange face with seal
3. Surface prepared with MBX Bristle Blaster
4. Completed application of Belzona 1341
