BELZONA PROTECTS THE DRINKING WATER

40 year old irrigation/potable water pump.

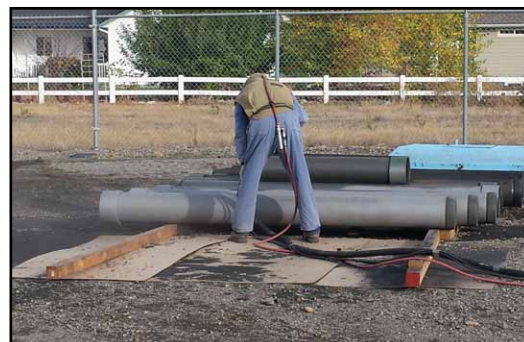
1. Gritblasting
2. First coat on the pipe
3. First coat on the pump
4. Second coat complete and ready for installation

The surface was grit blasted to Belzona standards of a near white finish. Then Belzona 5811DW was brush applied in two coats.
