## BELZONA HELPS FIREFIGHTERS DO THEIR JOB

Water pump on a firetruck.

Pump cavitation damage.

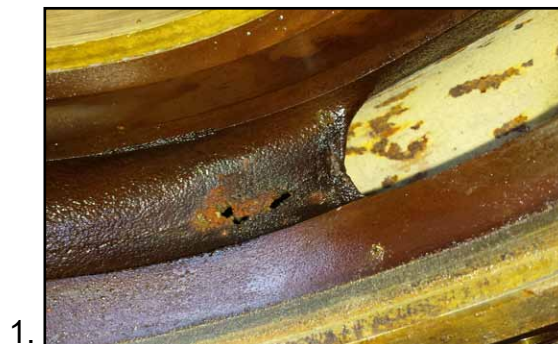
1. Corrosion damage
2. Grit blasted and ready for the application of Belzona 1311
3. Application of Belzona 1311
4. All parts coated and ready for assembly

The application was carried out in accordance with the Belzona Know-How System Leaflets CEP-1 and CEP-3. Surface preparation was carried out by grit blasting to a near white finish. Belzona 1311 was applied by using a formed piece of applicator trimmed down to the same size and shape of the damaged volute area. Belzona 1341 was brush applied in two coats as recommended.
