BELZONA FILLS THE GAP BETWEEN SKID AND DECK

Gulf of Mexico, USA

February 2016

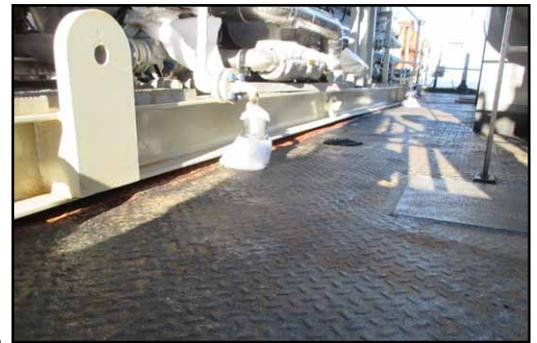
A new skid package was welded to the deck but did not sit flush, due to uneven surfaces. The deck was losing metal from corrosion and had several holes in it.

1. Gap between skid and deck.
2. Holes in deck repaired with Belzona 1121.
3. Surfaces primed with Belzona 3921 and gap filled with Belzona 2211. Belzona 9331 is test fitted to bridge interface.
4. Completed application with Belzona 3111.

To avoid water and debris from getting between the skid and deck, the gap between the two had to be sealed. Hot work would take weeks to weld the entire perimeter as the gap was 1.5" in some places. The seal also needed to be flexible to absorb any possible vibration.
