BELZONA RESCUES A PIPELINE AT THE CRUNCH TIME

Gulf of Mexico, USA

March 2016

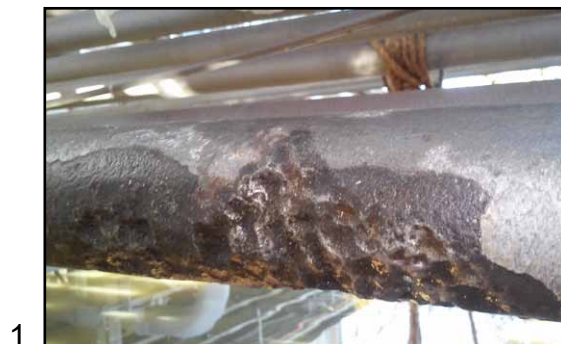
Customer had two ethyl glycol lines needing repair. The pipes were located near the waterline and access was difficult. One pipe had several through-wall defective areas whereas the other had thin-wall defects.

1. Original condition. Significant exterior corrosion causing wall loss.
2. After abrasive blasting shows several holes.
3. Post curing composite wrap with heat tape.
4. Completed application.
