## OIL COOLERS PROTECTED WITH BELZONA

Deer Park, TX, USA

March 2016

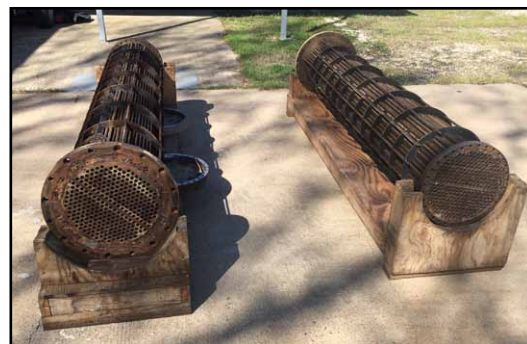
The customer was getting cross contamination between process cooling water and process lubricating oil, due to the corrosion at the copper tube and carbon steel tube sheet interface.

1. Chillers derived with pitting on tube sheet face.
2. Picture of end covers with pitting.
3. Finished end covers with final coat of Belzona 1321.
4. Repaired tube sheets with Belzona 1121 and Belzona 1321.

The application was carried out in accordance with Belzona Know-How System Leaflet HEX-1. First, all of the tubes were corked. Then the surface of tube sheets and end covers were blasted. The tube sheet was then rebuilt flush and the pitting on end covers were filled in with Belzona 1121. All surfaces were coated with 2 coats of Belzona 1121 as per IFU.

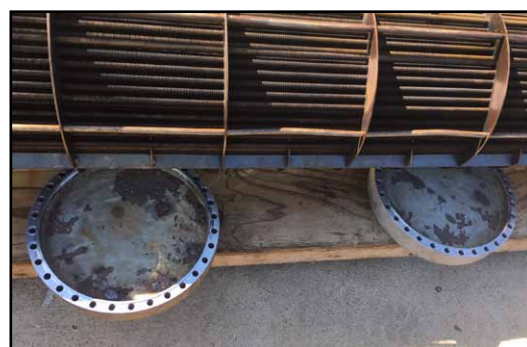
2.

The tube sheets and end covers of heat exchangers used for oil cooling were suffering from corrosion.
