BELZONA "SMOOTH RIDE" APPLICATION OF EXPANSION JOINTS SAVES BOTTLES

Concrete floor at a warehouse.

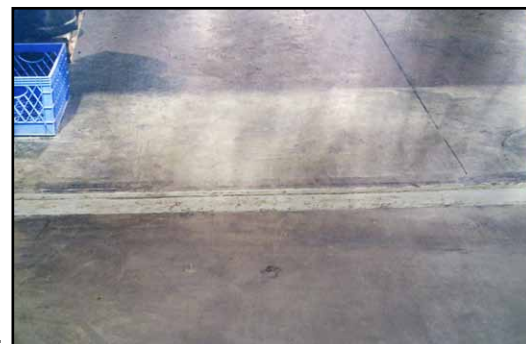
The warehouse floor suffered from uneven surfaces and bumps, causing product spills and long man hours to ensure cleanliness and safety.

1. Concrete below grade at old doorway.
2. Applying Belzona 4911 after surface preparation.
3. Belzona 4111 trowelled smoothly over the defect areas.
4. Repair holding up to forklift traffic years later.
