BLENDER LINER AT PARTICLE BOARD MANUFACTURER RESTORED WITH BELZONA

Liner of the blender used to mix wooden particles.

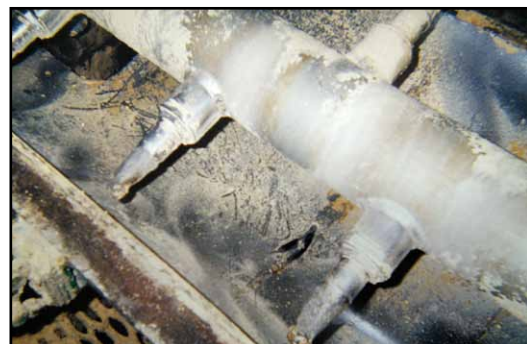
Wood particles being mixed with resins in this blender caused a very abrasive condition. Even though the liner to this equipment was designed to withstand abrasion it still suffered the effects. Particle board manufacturer was in the habit of welding new liners into this equipment when they wore out. The liner replacements were expensive and time consuming having to remove the worn liner and weld in the new one. This required extensive hot work in a wood laden environment and would typically warp the equipment causing misalignment of the lid.

1. Blender liner showing damage caused by erosion
2. Surface preparation completed
3. Belzona 1311 applied to the worn areas
4. Completed application with Belzona 1321
