BELZONA REPAIRS A SCREW PUMP

Screw pump at a pulp and paper plant.

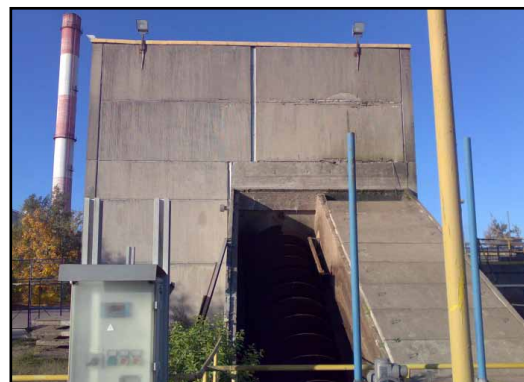
1. General view of two screw pumps
2. Cleaning of the gutter using high pressure equipment in progress
3. The depth of the applied material shown
4. Application of Belzona 5811
