BELZONA PROVIDES LONG-TERM SOLUTION FOR SPALLED CONCRETE

School, Essex, UK

March 2016

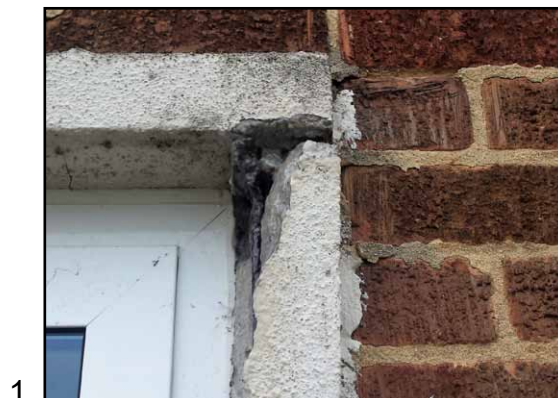
When the windows were replaced it became apparent that there were major issues with spalled concrete on many of the window sills and lintels. Large chunks of concrete were breaking away and causing a hazard for staff and pupils. The repairs had to be able to be carried out with minimum disruption to the school's usual activities.

1. A severely spalled corner piece
2. A cracked and spalled lintel
3. The repaired corner piece
4. The repaired lintel

Application was carried out in accordance with Belzona Know-How System Leaflet WPA-4. All loose debris was removed and the area cleaned before applying Belzona 4911 followed by Belzona 4141 to restore the original profiles. No special shuttering was required and the repairs were carried out easily with trowels.
