BELZONA COLD REPAIR TO LEAKING PIPE JOINT

City Council, Newcastle, UK

March 2016

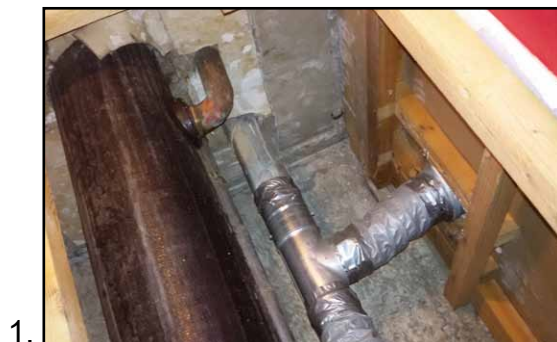
Tenant on 10th floor of block of Flats was experiencing a leak from flat above causing water damage.

1. Pipe/Joint location
2. Close up of corroded joint
3. Joint sealed/repaired

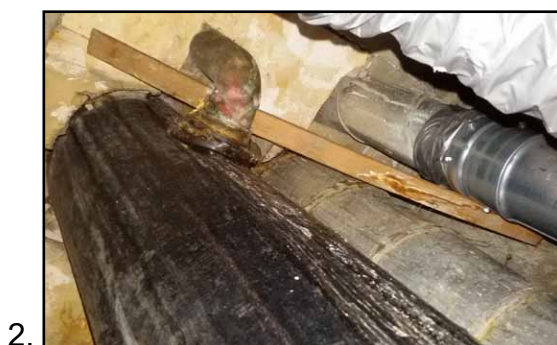
On investigation it was found that pipe was leaking at the joint and fittings were corroded.
