BELZONA REPAIRS LEAKING HEXANE PROCESS PIPE

Adhesive Manufacturer, Cramlington, UK

February 2016

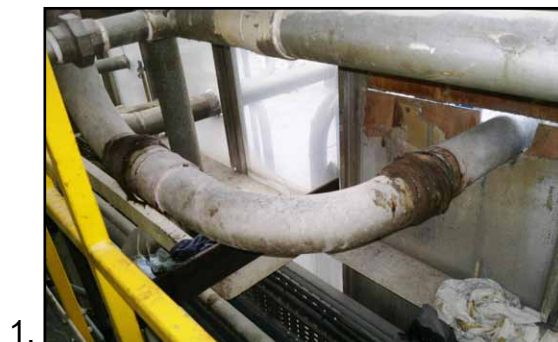
Customer had been using a temporary pipe wrap which did not offer a permanent solution. Leaking of the pipe was a Health & Safety issue due to the volatility of the Hexane product flowing through the process pipework.

1. Temporary pipe wrap
2. Removal of temporary pipe wrap
3. Permanent Belzona repair
