BELZONA REBUILDS AND PROTECTS TURBINE RUNNER

Hydroelectric Plant, Jokkmokk, Sweden

2014

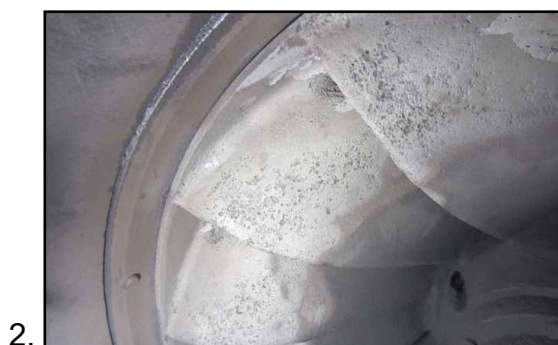
Two impeller runner blades had suffered severe cavitation and erosion damage.

Constant use had damaged the vulnerable cast iron substrate of the impellers. The client needed a quick, long-term solution to avoid downtime to their plant.

1. Turbine housing entrance
2. Cavitation damage to the runner
3. Close-up of the damage
4. Completed application

Application was carried out in accordance with Belzona Know-How System Leaflets CEP-1 and CEP-3. Surfaces were grit blasted prior to rebuilding with Belzona 1311 to restore profiles and coating with Belzona 1321 to provide long-term protection.
