BELZONA REFURBISHES TRAIN DIESEL TANK

Steel diesel tank originally coated in fibreglass in order to protect the metal against sparks.

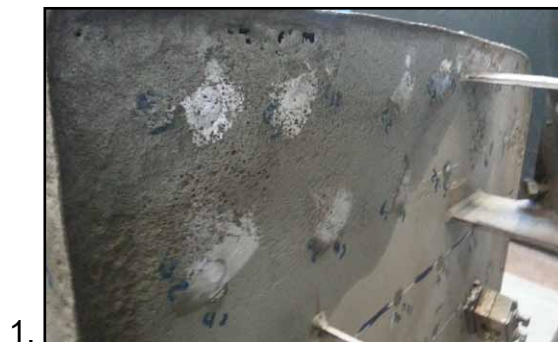
Moisture was entering the gap between the steel tank and the fibreglass coating, resulting in corrosion damage and leading to pitting and holes.

1. The corroded diesel tank before treatment
2. Lower portion of the tank prior to treatment
3. Tank plate-bonded with Belzona 1121 and coated in GRP
4. Repaired tank refitted to train

Application was carried out in accordance with Belzona Know-How System Leaflet TCC-1. The fibreglass coating was grit blasted away. Metal plates were then cold bonded over the defects using Belzona 1121 and the tank then re-coated with GRP, painted black and refitted onto the trains.
