BELZONA TACKLES AN EXPLOSIVE SITUATION

Steel producer, Czech Republic

The gas supply line for a blast furnace

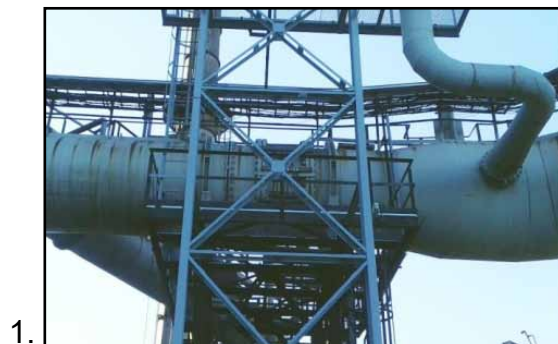
Pipeline had developed a crack which was leaking gas into the atmosphere. The repair had to be performed live. The intake pipe had a diameter of 2,000mm and had developed a crack 2,500mm long and 2mm wide.

1. The damaged pipework
2. Applying the first seal of Belzona 1211
3. Main layer of Belzona 1111 and sheet applied
4. Completed application
