BELZONA UPGRADES BASEMENT TO PLANT ROOM USE

University, Cambridge, UK

February 2016

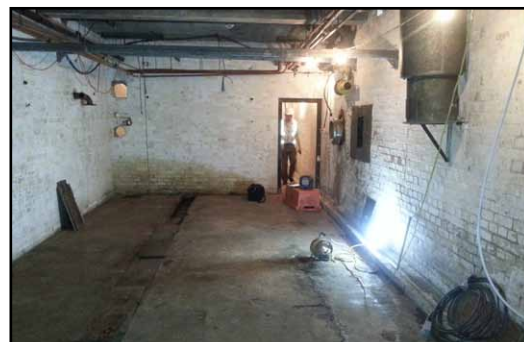
The existing concrete floor had many broken and damaged areas and the steep steps down into the basement were smooth and slippery

1. Disused basement before
2. Belzona 4111 and 4131 being installed to repair floor
3. Completed plant room with floor coated with Belzona 5231
