BELZONA REFURBISHES SPLIT CASE PUMP

Distillery, Glasgow, Scotland

May 2016

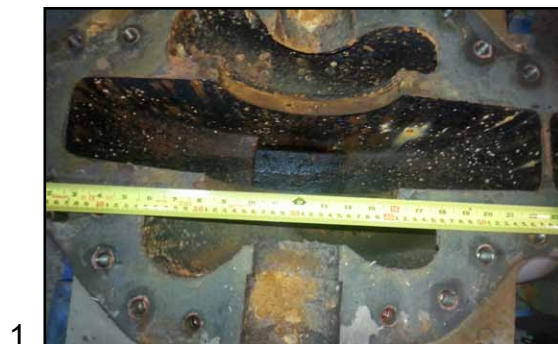
Pump had been experiencing erosion/corrosion. Damage had occurred to the existing coating & some of the underlying steel substrate had been eroded away. If another model of pump were to be installed in this instance the surrounding pipework would have to be modified.

1. Pump casing before
2. Damage before
3. Casing after application of Belzona 1341
4. Completed application

The application was carried out in accordance with Belzona Know-How System Leaflets CEP-1 and CEP-3. The damaged areas around the wear rings were rebuilt with Belzona 1111 before the casing was coated with two coats of Belzona 1341.
