BELZONA KEEPS THE FLOW GOING

Tire Manufacturer, Czech Republic

Pumps from cooling water system

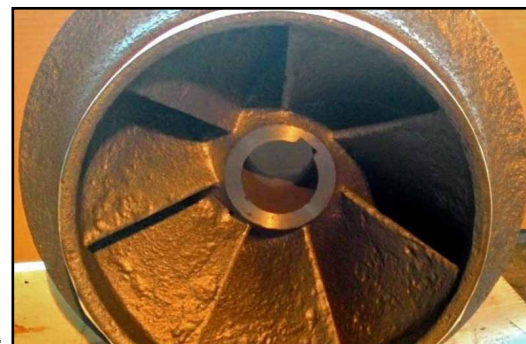
Impeller vanes on water pumps had been damaged by cavitation erosion corrosion, leading to reduced efficiency.

1. The damaged impeller
2. Surface profile being restored with Belzona 1111
3. Impellers finished with Belzona 1341

Application was carried out in accordance with Belzona Know-How System leaflet CEP-10. Original profiles were restored with Belzona 1111 before applying two coats of Belzona 1341 to provide future erosion corrosion protection to the impellers.
