## BELZONA RESTORES VACUUM PUMP

Brewery, Serbia

Vacuum pump rotor.

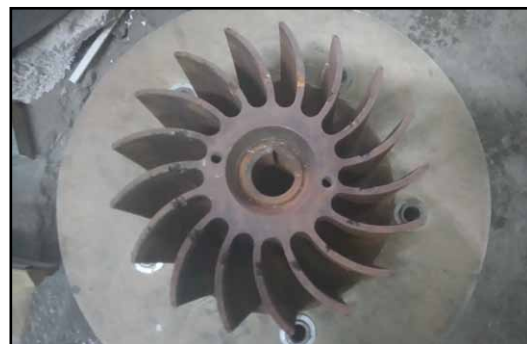
The vacuum pump rotor was exposed to aggressive corrosion and its efficient working life was very short. The client required a solution that improved the performance of the damaged pump and gave it new life.

1. Overall condition of rotor
2. View of the condition of the rotor
3. Impeller after grit blasting
4. Completed application

The application was completed in accordance with Belzona Know-How System Leaflets CEP-1 and CEP-3. After grit blasting the rotor was reconstructed with Belzona 1111. Once the shape of the rotor was reformed it was overcoated with Belzona 1321 to provide future erosion corrosion protection.
