CAST IRON BELZONA GRIP ON COAST

Port Authority, Teesside, UK

Ancient Cast Iron Steps leading down to the breakwater and beach.

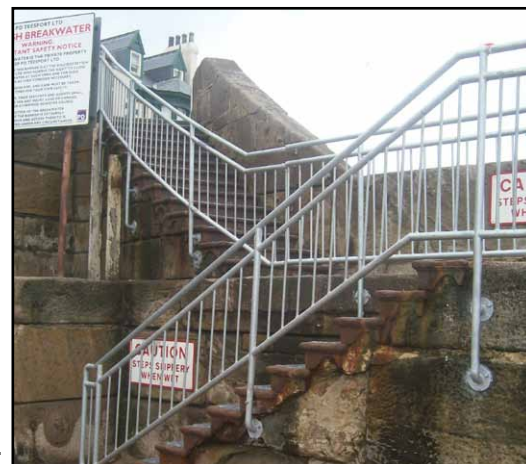
1. 25 steps to the breakwater and beach
2. Cast iron worn smooth
3. Same steps after application
4. Completed application

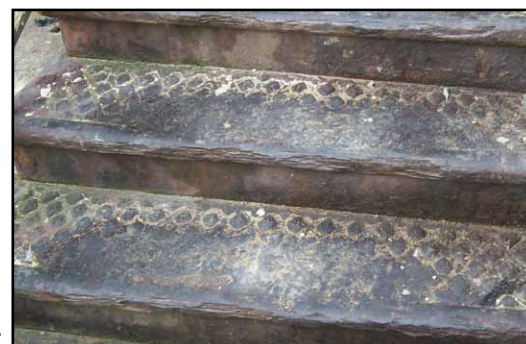
2.

These steps had been worn down after decades of use from the public. The polished surfaces were slippery even when dry, and in wet conditions they were treacherous. These steps led to a very popular breakwater and beach, and so access through the day could not be restricted. In addition, there was about to be a major "Big Ships" event, and thousands of visitors were expected to be using these steps. With "Slips & Trips" being the main source of reported injuries in the UK, the client was very conscious of the risks to the public.
