CHECKER PLATE ROOF JOINTS SEALED WITH BELZONA

Petrochemical Plant, UK

Checker plate roofing panels over heating unit.

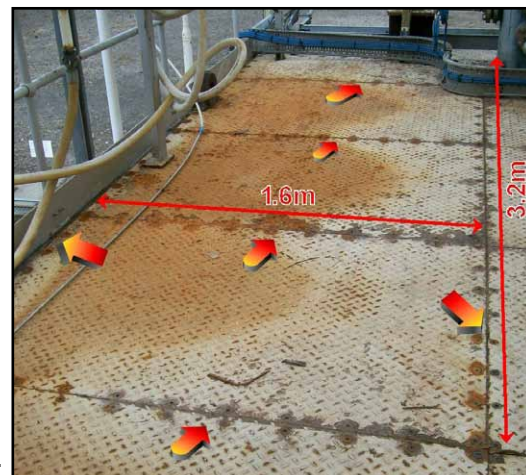
The checker plate panels were landed on a gasket seal. Unfortunately, the seals for several panels had failed and water was penetrating into the asset. A bigger problem was presented by caustic vapours escaping from the joints during certain production phases. With no planned shutdown imminent, the client was urgently seeking a solution that could be rapidly installed. The site had many flammable materials and so only cold works and minimal preparation would be allowed.

1. Heater roof with failing joints identified
2. Belzona 3121 being mixed before application to the prepared joints
3. Final application revisited after 1 year
