CHILLER REPAIRED AND PROTECTED WITH BELZONA

Five Star Hotel, Bali, Indonesia

End Cover, Tube Sheet and Pipe Header of Trane Chiller from Hotel's Air Conditioning Plant.

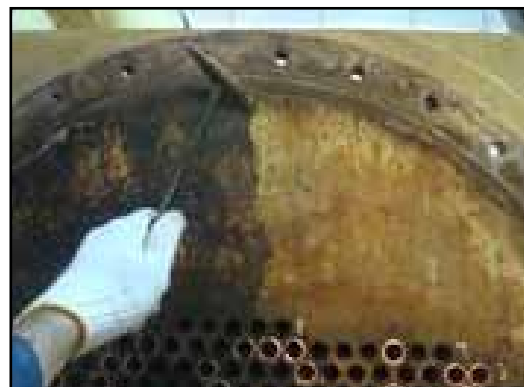
Erosion-Corrosion on all water side chiller components

1. Severe corrosion and deep pitting on Chillers surface.
2. Belzona 1311 being applied to rebuild eroded areas.
3. Appearance after internal coating on Tube Sheet and Pipe Header with Belzona 1321 and Belzona 5811.
4. Inspection after 1 1/2 years operation shows Belzona application still in perfect condition.

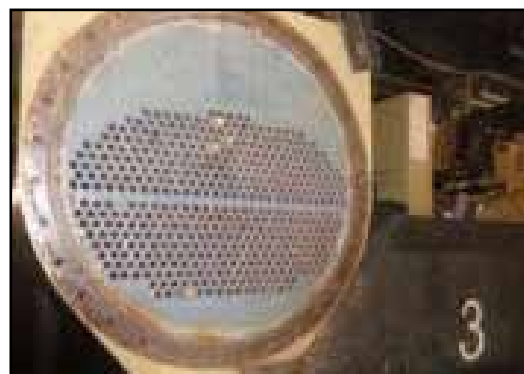
4.

Belzona system both restored eroded metal and provided corrosion protection to all parts of the chiller. In March 2016, the chillers were inspected. The Belzona application was still in excellent condition.
