BELZONA KEEPS THE CHIPPER CHIPPING

Shaft repair for spun bearing at a lumber mill.

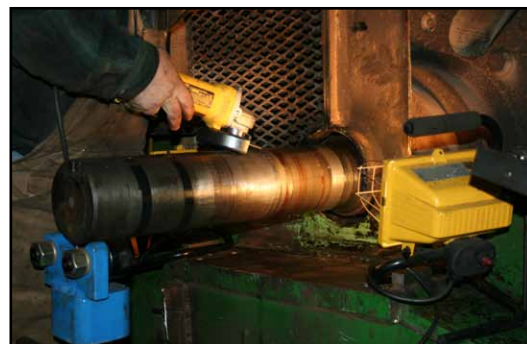
The bearing on the chipper disc shaft had spun out, damaging the shaft.

1. Damaged chipper disc shaft being ground.
2. Shaft ground down and clean.
3. Belzona 1111 applied to the shaft and the former is in place with heat lamps.
4. Completed repair, ready for reassembly.

This application was completed on a Saturday in November, below freezing outside and the job was located in an unheated area of the mill. All the mixing was done in a heated area and then moved to the area of the repair. The application was carried out in accordance with Belzona Know-How System Leaflet MPT-2. The damaged area was ground down on the shaft and then cleaned thoroughly with Belzona 9111. Belzona 9411 was applied in 2 coats to the two part steel former that was made. A thin layer of Belzona 1111 was applied to the former, and about a 1/4" layer of Belzona 1111 was applied to the prepared shaft area. The former was then mounted on the shaft and tightened down, squeezing the excess material out. Heat lamps and a heat gun were used to warm the shaft due to the temperature. After approximately 2 hours, the former was removed and the initial clean up was done. The following day, Sunday, it was sanded down and the new bearing and sleeve were mounted. Then the chipper disc was reassembled. The chipper was successfully returned to operation on Monday.
