BELZONA SUPERWRAP REPAIRS VESSEL NOZZLES ONLINE

CNOOC Shanghai, China

Leaking nozzles needing long term repair

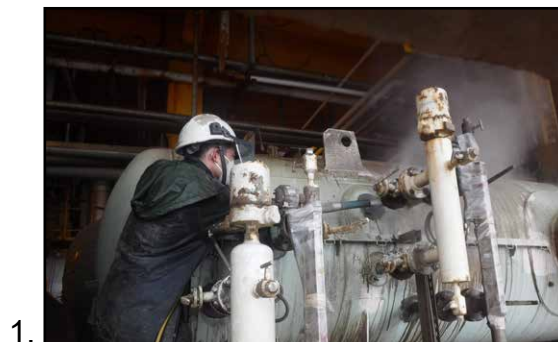
1. Vapor blasting
2. Nozzle after vapor blasting
3. SWII application
4. SWII applicataion finished

SWII was designed and applied according to ISO 24817 standard. The explosion-proof vapor blasting was taken for surface preparation. The application was carried out in accordance with a modified version of VPF-11 System Leaflet.
