BELZONA REPAIRS A RESTAURANT ROOF

Thailand

February 2017

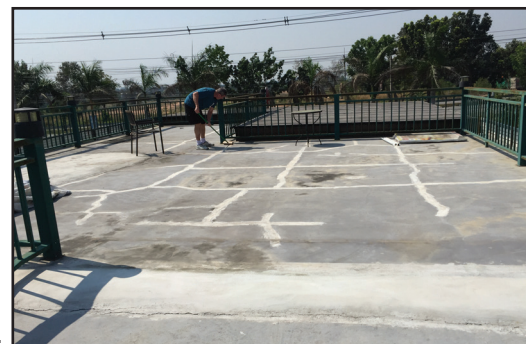
1. Surface Preparation
2. Applying Belzona 3911 (PSC Surface Conditioner)
3. Application of Belzona 9311 Reinforcement Sheet wetted out with Belzona 3111
4. Complete application

The application was carried out in accordance with Belzona System Leaflet RPA-1. The area was made clean, firm and dry prior to application. Problem areas were masked off and Belzona 3911 was applied. Once touch dry, Belzona 9311 Reinforcement Sheet wetted out with Belzona 3111 was applied. Finally, a top coat of Belzona 3111 was applied to complete the system.
