BELZONA 1111 REBUILDS TOWBOAT DRIVE

Erosion damage to the cast steel housing of this Schottel drive on a towboat.

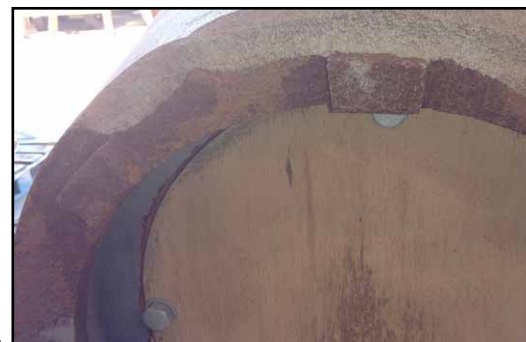
After 64,000 hours of operation, a fair amount of erosion had occurred starting to compromise the mating face of this drive unit. Up to 1.5 inches of missing steel in the worst places.

1. Original condition showing erosion.
2. Blasted and ready for the application.
3. Partially completed.
4. Application complete.
