BELZONA ABRASION RESISTANT LINING FOR DEBARKER

Paper Mill, Poland

Rotating debarker drum

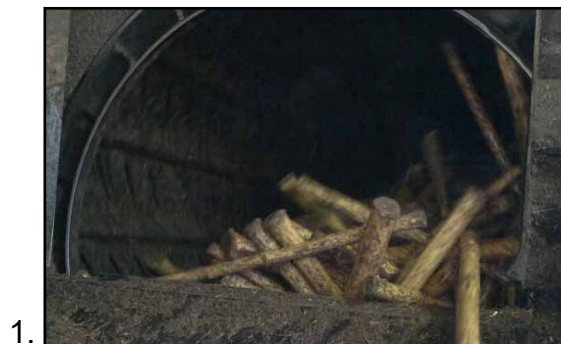
The steel protection plates were wearing away due to severe abrasion. They required a solution to prolong the life of the equipment. If the problem was not resolved during the planned maintenance period, then the customer risked a unscheduled stoppage to the plant and costly downtime.

1. Debarkers create a very abrasive environment
2. Surface preparation prior to application
3. Layers of Belzona 1321 and 1811 applied
4. Belzona 1811 lining of debarker
