BELZONA PROTECTS LEADING EDGE OF WIND TURBINE BLADES

Québec, Canada

Summer 2017

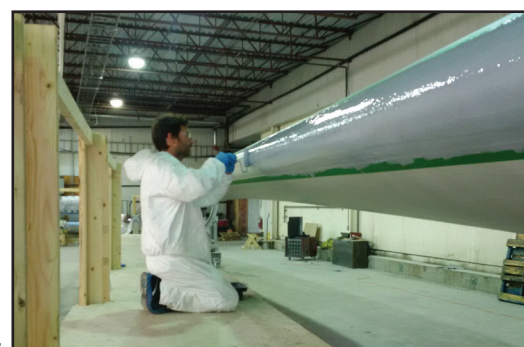
1. Belzona personnel arriving on site to support the application.
2. Belzona 1341 being applied by roller in the outlined and prepared LEP area.
3. & 4. LEP coating complete with Belzona 1341

The application was carried out in accordance with a modified version of Belzona Know-How System Leaflet FBC-1. The blades were coated on the ground in a large shop area as they were going to do general maintenance on them. The pitting and loss of surface on the leading edge was resurfaced in with a filler product and rebuilt to dimensions. The outlined Leading Edge gel coated surface area was sanded down with a mechanical sander with 80 grit sandpaper and cleaned down with a rag and non-residual solvent cleaner. One coat of Belzona 1341 was applied by roller to an average mil thickness of 12 mils.
