CHEMICAL TANKS GIVEN SUPPORT WITH BELZONA CHOCKING COMPOUND

Courtright, Ontario, Canada

October, 2017

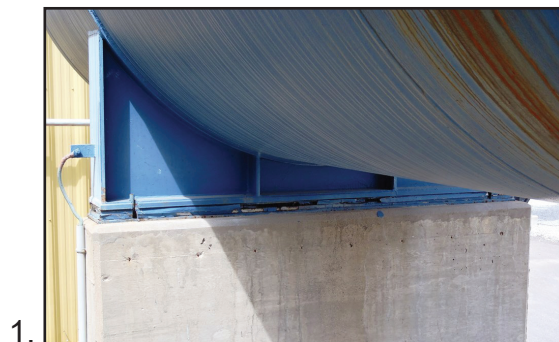
Three 96" dia. x 20' long bulk sulfuric acid and caustic storage tanks located in the water treatment plant. The 1.5" - 2" thick existing grouting system between the steel supports and the concrete base has become broken and dis-bonded. This has exposed the wooden leveling shims. The wooden shims have become rotten over time and require removal and replacement.

1. Failed existing grout between tank base and concrete base
2. Removal of rotten timber packing and shim material
3. & 4. Installed Belzona 7111
