## BELZONA 1212 SEALS LEAKING COPPER GUTTERS AT UNIVERSITY

College, Cambridge, England

August 2017

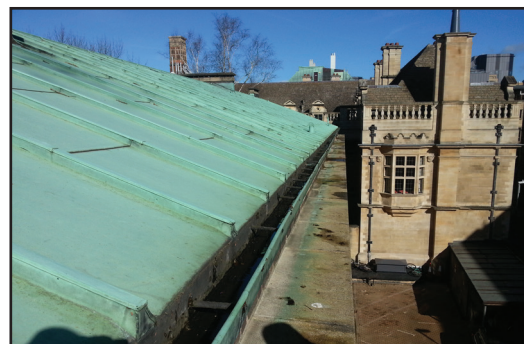
The 56 joints in the copper gutters had been constantly leaking for almost 40 years causing unsightly staining on the building structure underneath the joints.

1. The College Building showing copper gutter and stains on stonework
2. Typical leaking gutter joint
3. Gutter joint cleaned and sealed inside with new copper plate bonded on with Belzona 1212
4. Flexible system being installed over every 4th joint bonded on with Belzona 1212
