## BELZONA BOND HATCH FLANGES

Cape Town, South Africa

September 2017

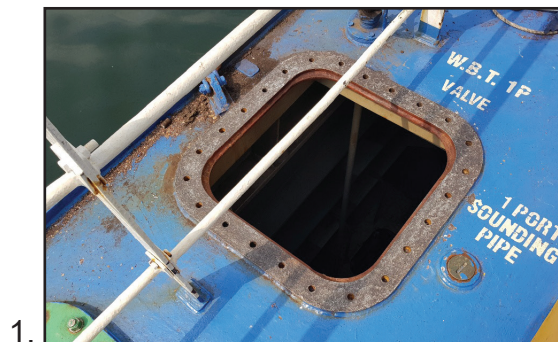
The manway hatches on this vessel had suffered from corrosion damage and began to disbond from the deck.

1. Damaged hatch flanges
2. Flanges removed and prepared
3. Hatch rebonded onto the vessel with Belzona 1111
4. Scope of work, all hatches were rebonded
