BELZONA TANK BASE SEAL STILL GIVING SUPERB PROTECTION

Petrochemical Plant, UK

Carbon Steel Fuel Storage Tank

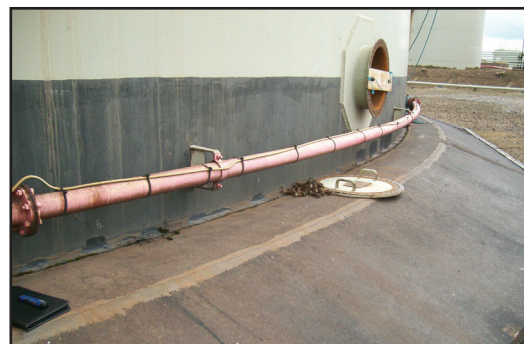
Over the years the bitumen and sand base under this 36m diameter tank had compressed, to such an extent that the annular rim was now at least 10mm below the surrounding concrete plinth. Water was actually being captured at the rim which had dramatically increased the risk of under base corrosion. Various mastics had been tried in the past, but all failed quickly.

1. Initial condition of tank.
2. Annular rim creating channel for water.
3. Tank Base Seal application in 2010.
4. Tank revisited in 2017.

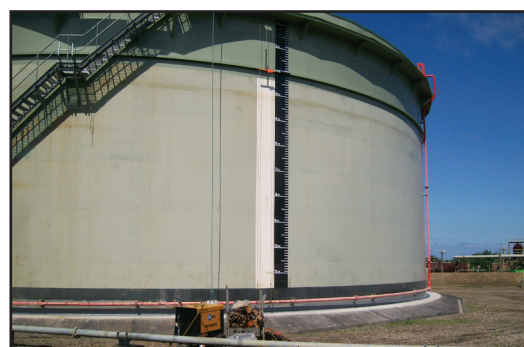
4.

For many years this Customer had recognised the long-term benefits of using the Belzona Tank Base Sealing system. After reprofiling the plinth, the Belzona Tank Base Seal was installed around the full diameter, preventing any risk of water ingress to the base. The work was inspected again in 2017 and is still in perfect condition. To date this client has protected over 50 tanks with the Belzona Tank Base Seal solution.
