BELZONA SAVES UNIVERSITY LIBRARY FROM WATER INGRESS

Library at Manchester University, England, UK

Long stretch of roof lights over library allowing natural light into the building.

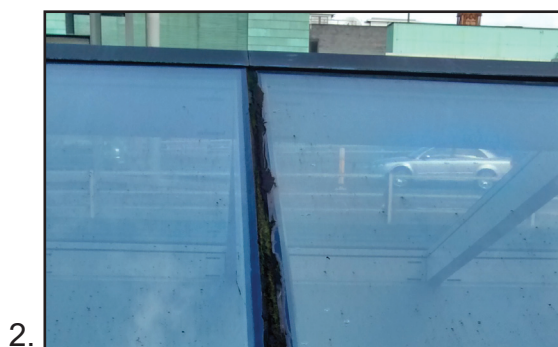
Water ingress was discovered resulting from failure of the sealing materials between the glazed units, caused by UV attack and constant movement due to thermal expansion.

PICTURES
