BELZONA SOLVES LONG-TERM WATER INGRESS ISSUES AT LAST

University, Manchester, England, UK

A large flat roof section divided by a walkway

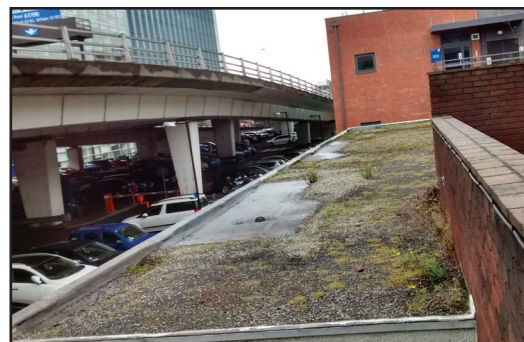
1. Overview of the roof areas before work commenced.
2. HVAC systems located on the roof before work commenced.
3. Completion of the HVAC areas.
4. Completed application.
