ROOF OF AN ART DECO BUILDING SAVED WITH BELZONA

Large bitumen felted flat roof on a beautiful Art Deco Public Building.

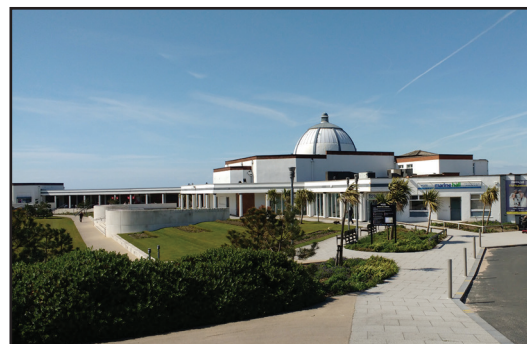
1. Overview of the building.
2. One small section of the roof before.
3. The same small section after application of Belzona 3111.
4. Belzona 3111 coated section close to the dome area.

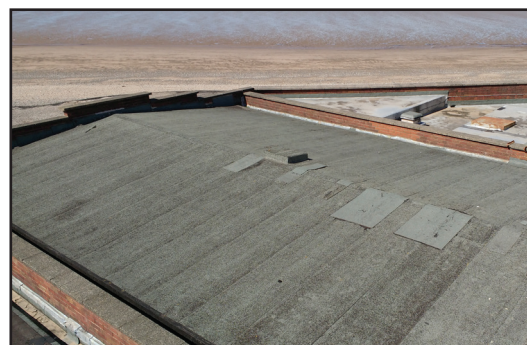
2.

The roof is a large expanse with several separate roof areas on different levels. There were numerous leak areas through the existing roofing felt that required repair to prevent permanent damage to the wonderful interior which is still used for numerous events on a regular basis including ball room dancing.
