BELZONA SOLVES CORROSION ISSUE ON SHEET EDGE ROOFING SECTIONS

Leisure Center, Fleetwood, England, UK

Large metal roof covering local leisure center.

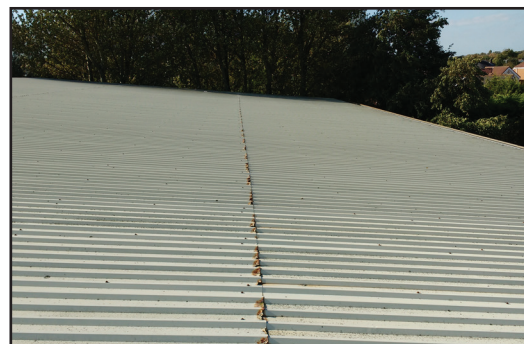
The area is close to the coast making corrosion of metal a real problem on exposed areas of mild steel. This large metal roof was suffering significant sheet edge corrosion damage.

1. Overview of roof area affected by sheet edge corrosion.
2. Close of of a badly damaged area.
3. Close up of a repaired area.
4. Overview of repaired roof area.
