BELZONA PROTECTS FLANGES FOR GAS WORKS

A section of pipework had an exposed flange that was deemed to be susceptible to corrosion.

The Customer required a solution that would protect the flange from corrosion whilst still allowing access for inspection at a later date.

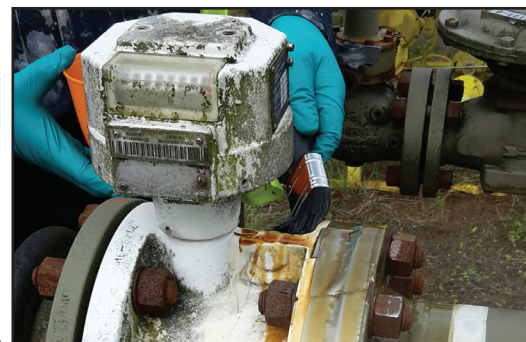
1. Flange with void taped
2. First coat during application
3. First coat applied
4. Second coat applied
