BELZONA SEALS PARAPET WALL

Shopping Centre, NSW, Australia

Parapet wall on the roof of a Shopping Centre

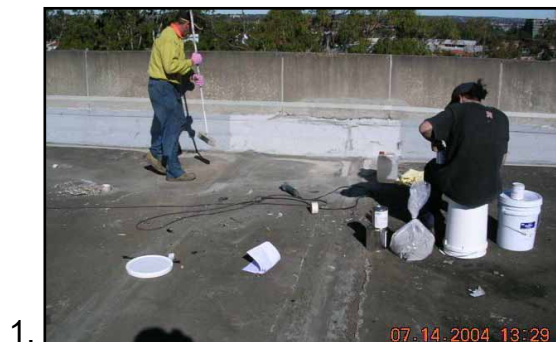
1. Preparation in progress
2. Surface Conditioner applied
3. Completed application

Application was carried out in accordance with Belzona System Leaflet RPA-8. A fully reinforced Belzona 3111 system was applied to bridge between roof deck and wall.
