## BELZONA PROTECTS DAMAGED BOOSTER FAN

Turkey

December 2012

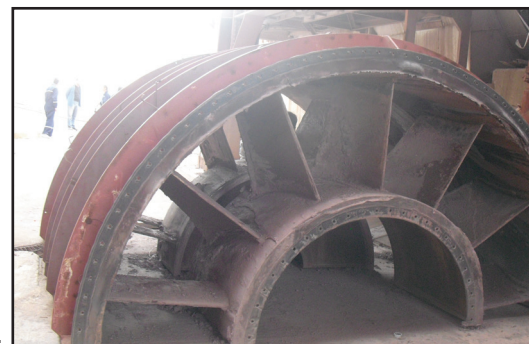
The booster fan from an electric powerplant had damage on the case around the diffuser and the fan housings. Damage caused by high temperatures and corrosion. Previous BIRR coating failed.

General and pitting corrosion occurring across the fan housing and diffuser. Pitting was filled and then whole area was coated with Belzona high temperature coatings.

1. Damaged booster fan.
2. Pitting damage and blasted substrate.
3. Application of Belzona 1391T.
4. Finished application.
