BELZONA PROTECTS SETTLEMENT TANK

Pharmaceutical Company, Slovakia

Damage to the tank and mixing equipment

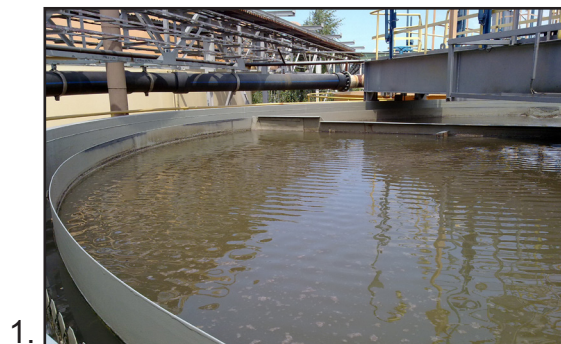
1. Mixing Basin
2. Extent of damage to the basin
3. Blasting of the basin
4. Completed application

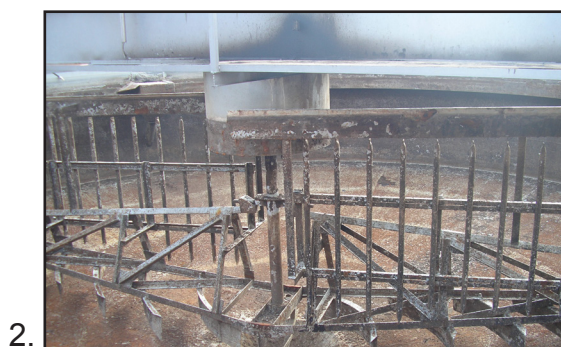
Erosion/corrosion damage was affecting the normal operation of the equipment
