## BELZONA PROTECTS INCINERATOR EXHAUST DUCT

Food Producing Company, Eastern Norway

Internal surfaces of incinerator exhaust duct used to dispose of waste from local food factory.

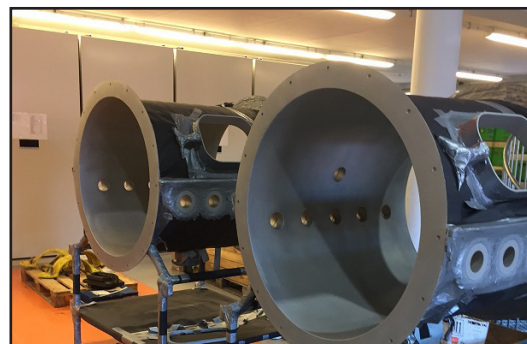
1. Units overview.
2. Gritblasting details and application preparation.
3. Coating application details.
4. Completed application ready for transport.
